FROM: CONTRAIL ROCKETS RESEARCH AND DEVELOPMENT

SUBJECT: LDRS 25 O MOTOR FAILURE ANALYSIS

DATE: 8/11/2006

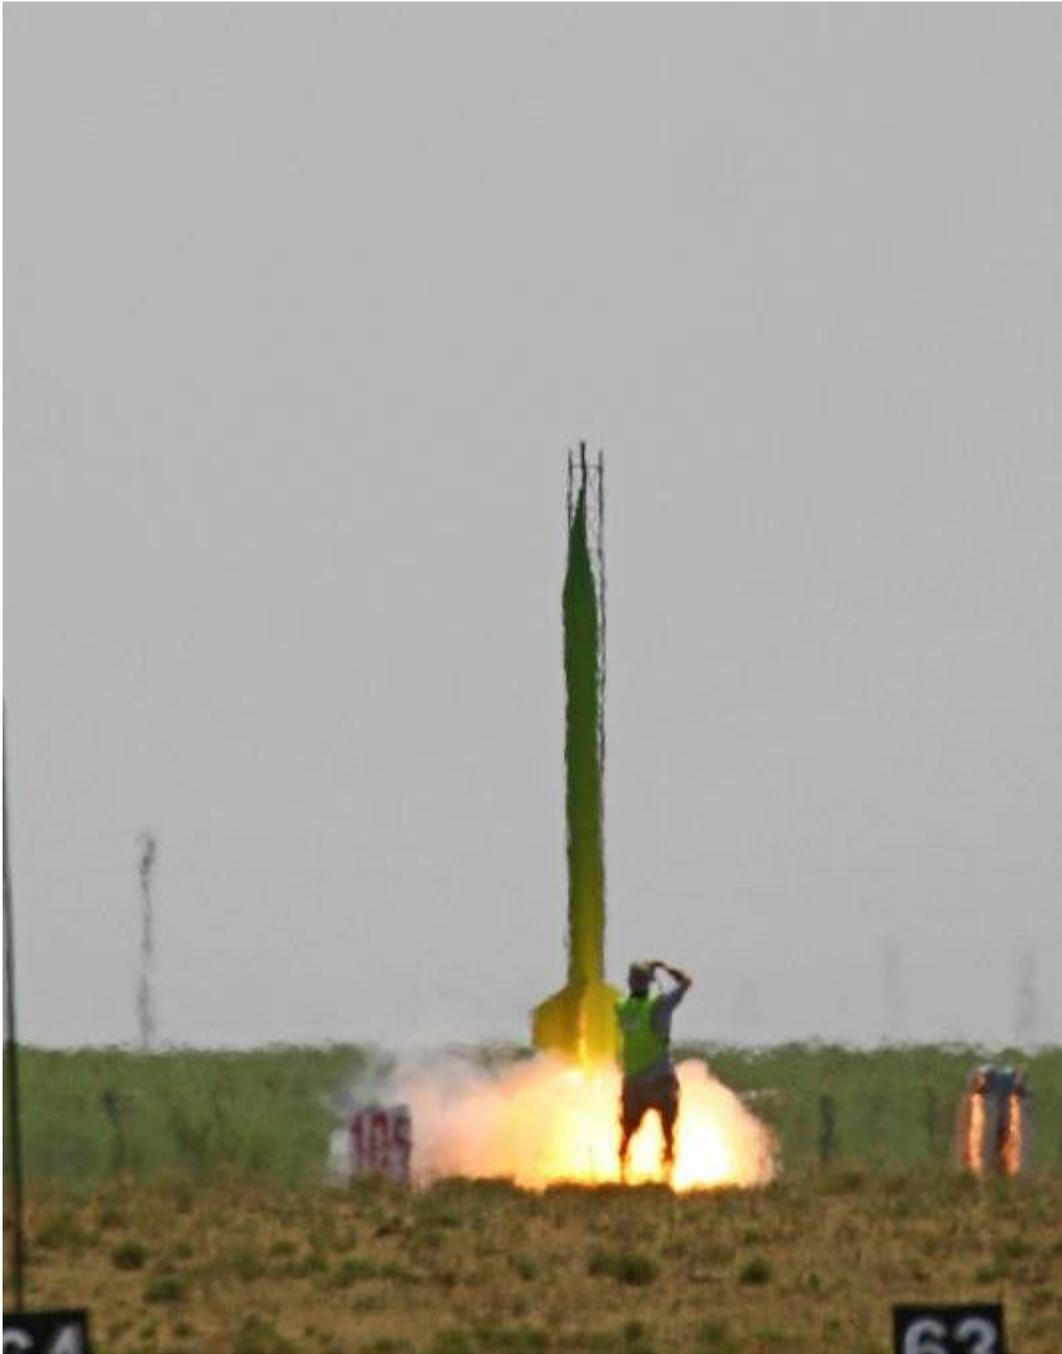
Above Photo Shows Ignition of O-6300. The Motor is just now coming up to full pressure and thrust. In less than .25 Seconds the motor will be operating at 2800 Pounds of Peak Thrust.

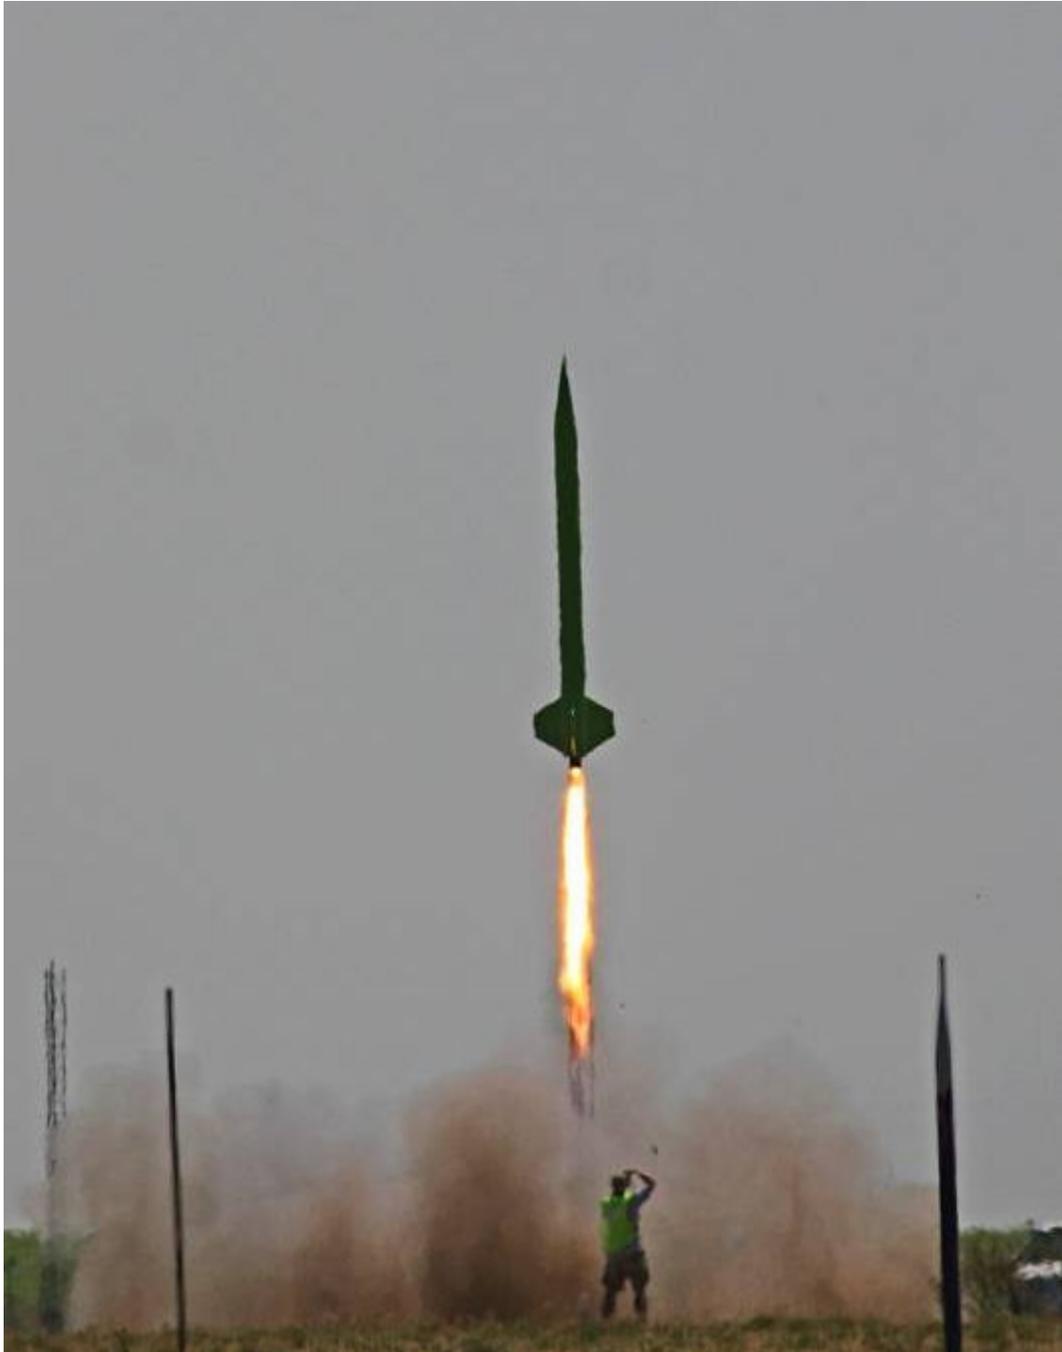
Above Photo Shows the rocket as it just leaves the Rail. Still there is no sign of any issue with the motor. Note that the rocket is 17 Feet Tall, and 12 Inches in Diameter.

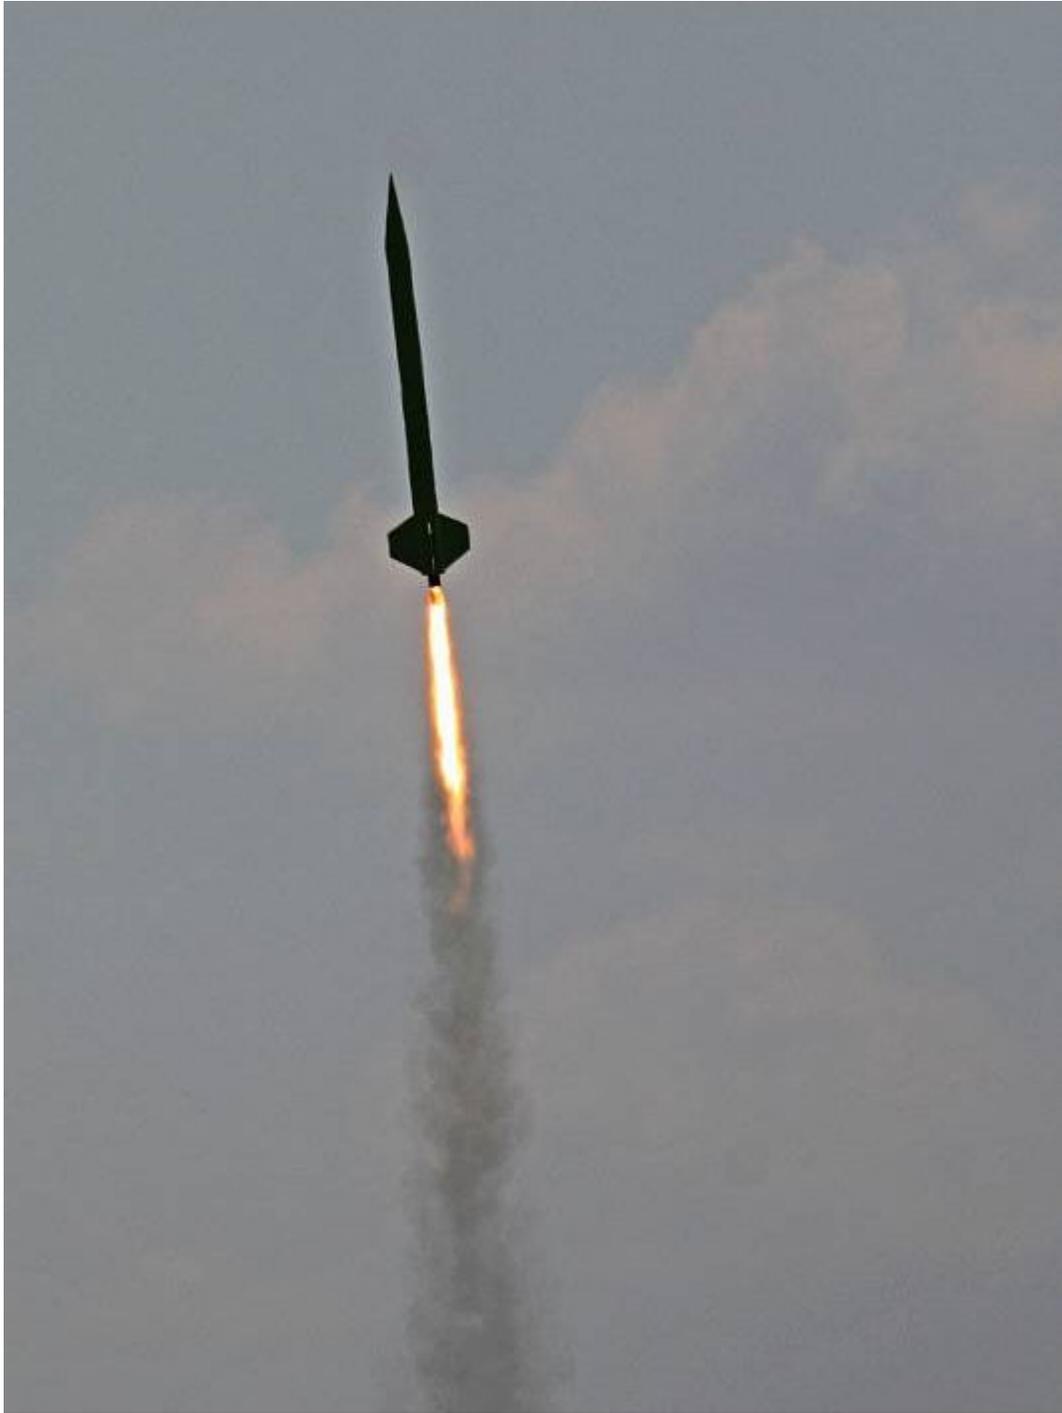
Above Photo Shows the Motor as it begins to have a regressive Thrust Curve. Over the 4.5 Second Burn the Motor will Reduce in thrust from 2850 Pounds to 0 Pounds.

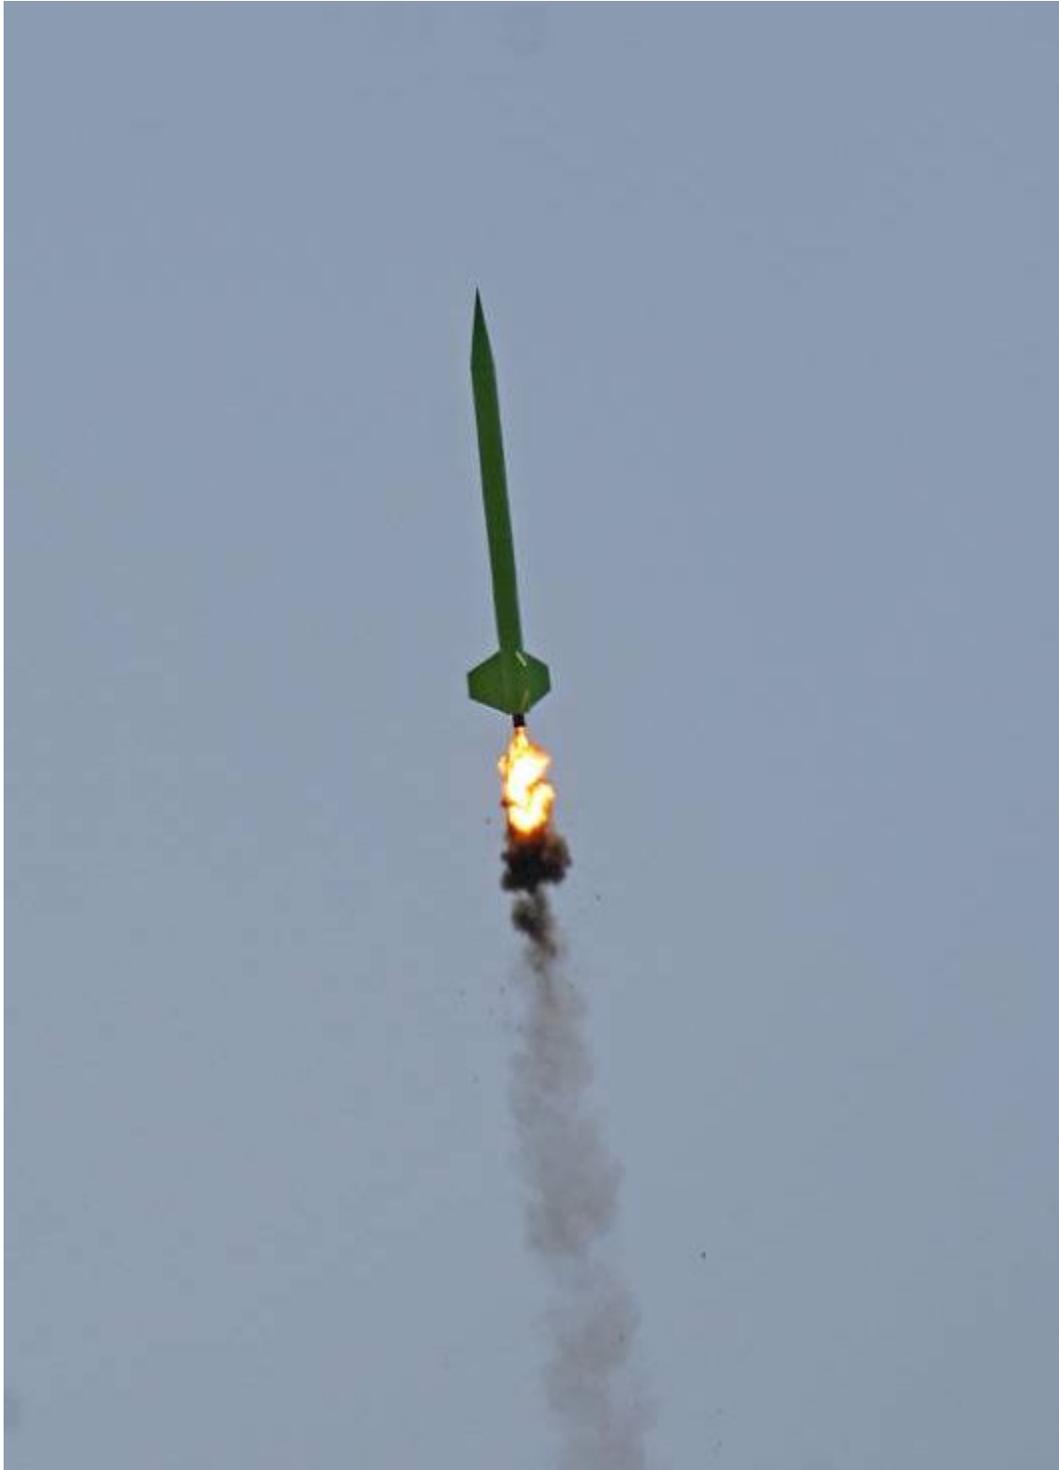
Above Photo: At this point during the burn the motor has “choked” itself up. The photo shows parts of the fuel grain which have been cracked from the previous days frostings and temperature cycling being ejected from the motor. The Flame is severely reduced due to the lack of flow into and out of the combustion chamber.

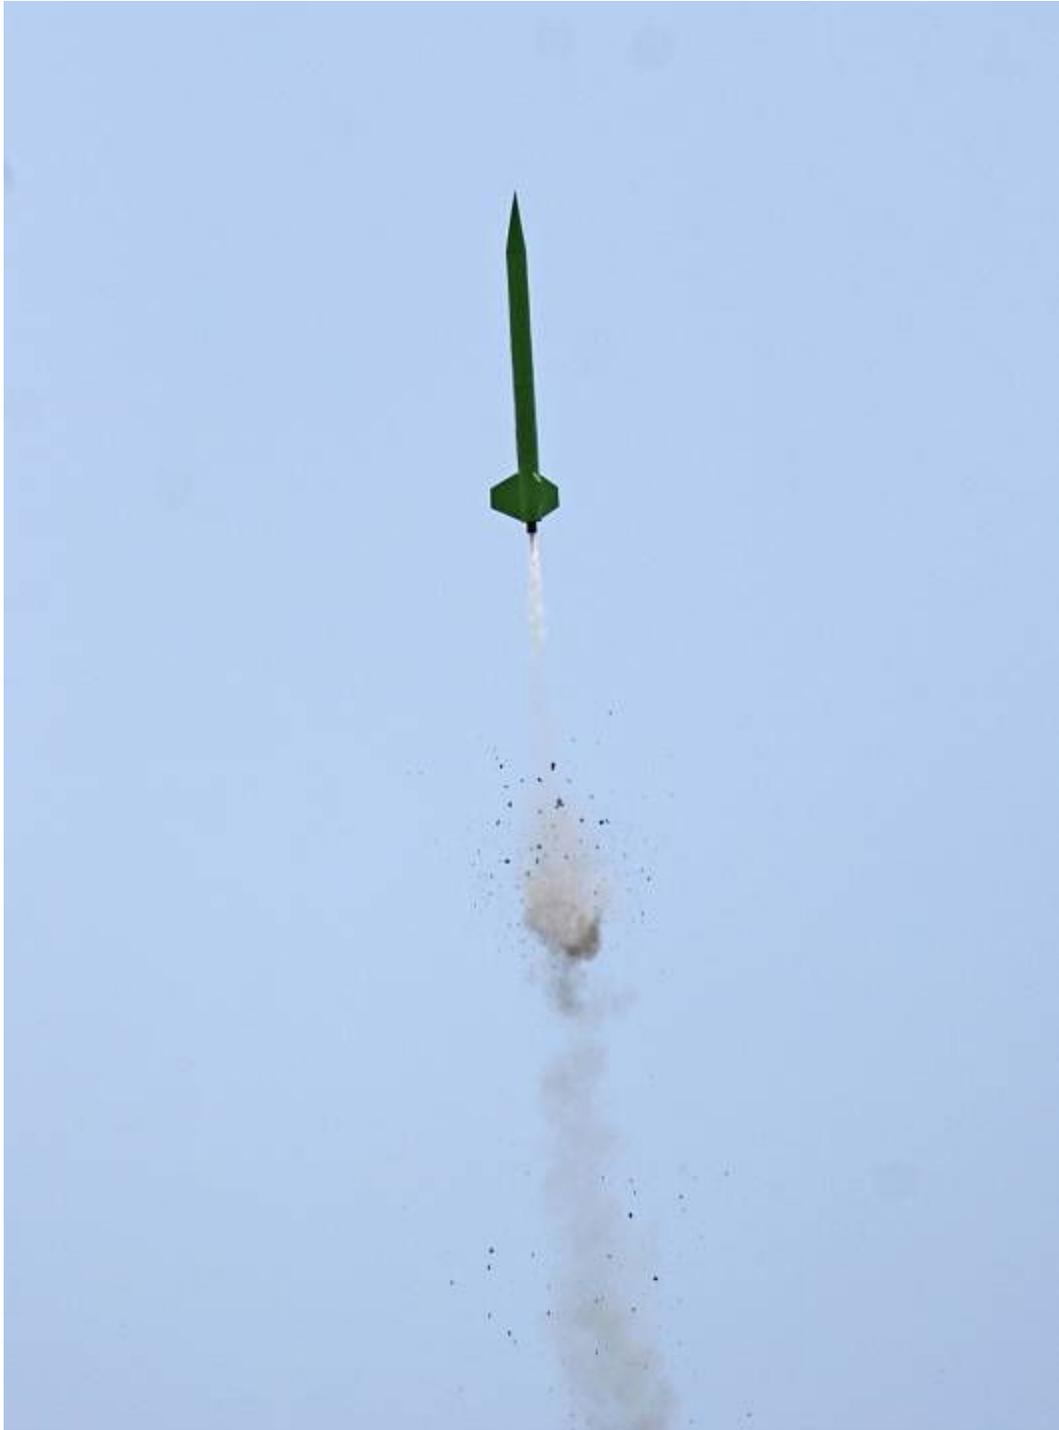
Above Photo Shows the Grain parts after the leaving the combustion chamber. These Parts of the grain were what had clogged the nozzle during the motor burn. The Grain Spit itself out and during that time the flame from the motor had disappeared. At this time the grain was compromised. While still burning and very hot, the thrust from the motor was severely diminished.

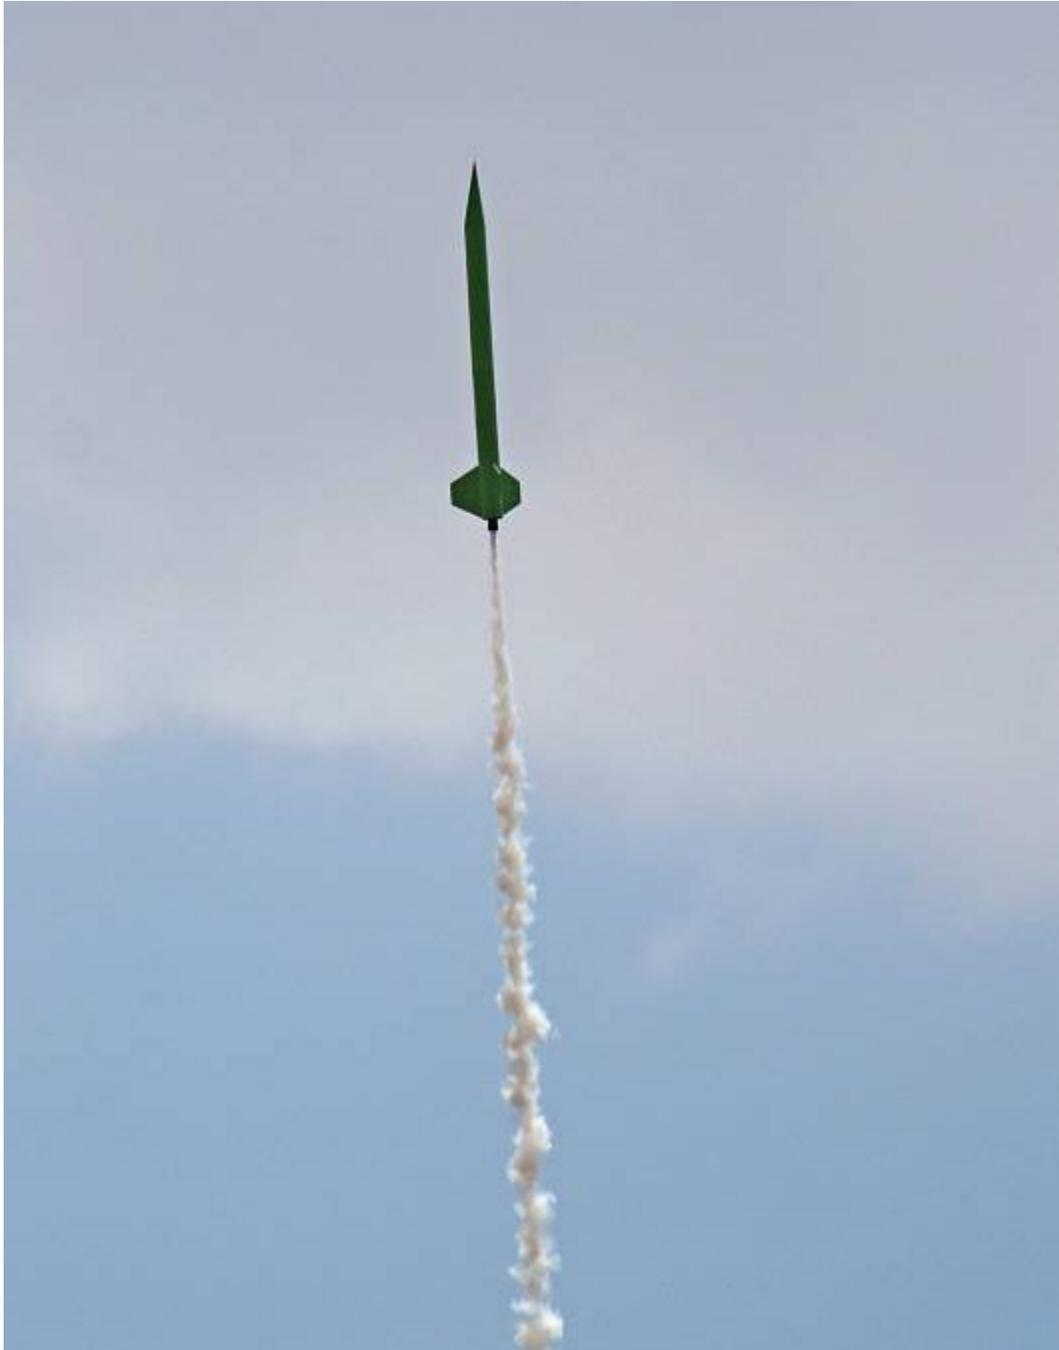
Above Photo Shows a continued movement of the rocket upward. The nozzle of the motor is believed to be partially clogged still, and is creating an environment in which the flame front of the motor is moving upwards into the Nitrous Tank portion of the hardware. It is believed that the Low Tank Pressure in the Motor allowed for the flame front to move up into the Nitrous Tank faster than if the motor was fired under optimal conditions.

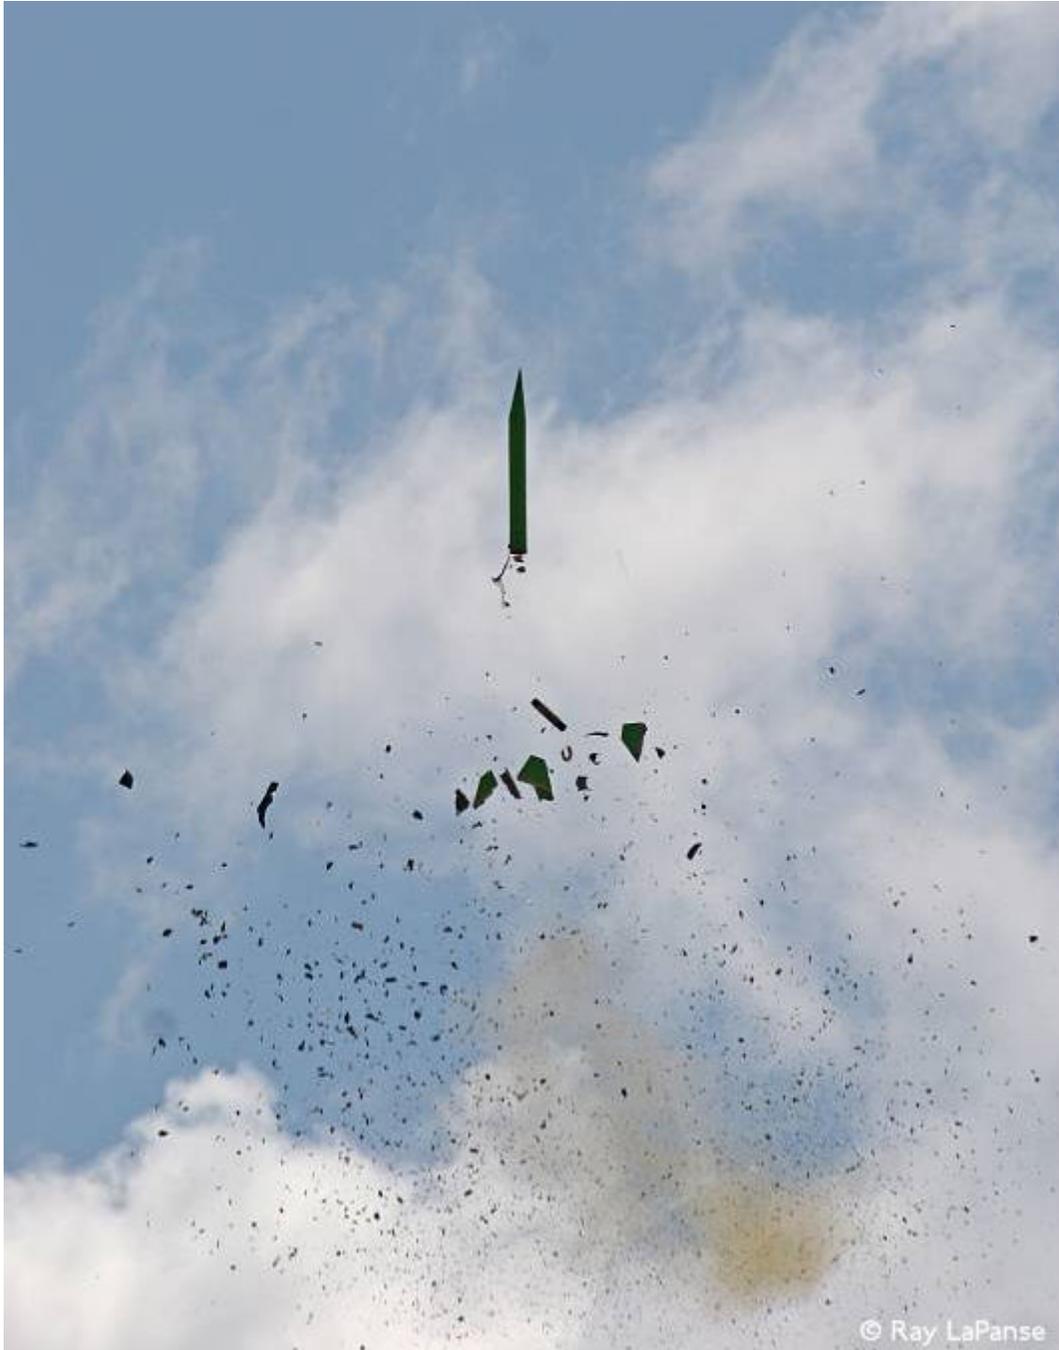
Photo Above Shows the Complete Destruction of the Lower $\frac{1}{2}$ of the Rocket. Immediately before this point the flame front had moved from the combustion chamber into the Nitrous tank and allowed for a “flashback” situation.

Current and New customers of the O-6300 all receive a video instruction manual and written instructions as well as a set of guidelines and regulations of how the motor should be prepped and fired. There are limitations to every motor. It has been found that the O-6300 Motor should not be fired with excessively low Nitrous Pressure.
